MAJOR ORIENTATION-ERROR ACCIDENTS IN REGULAR ARMY UH-1

AIRCRAFT DURING FISCAL YEAR 1969: ACCIDENT FACTORS

W. Carroll Hixson, Jorma I. Niven, and Emil Spezia

U. S. ARMY AEROMEDICAL RESEARCH LABORATORY

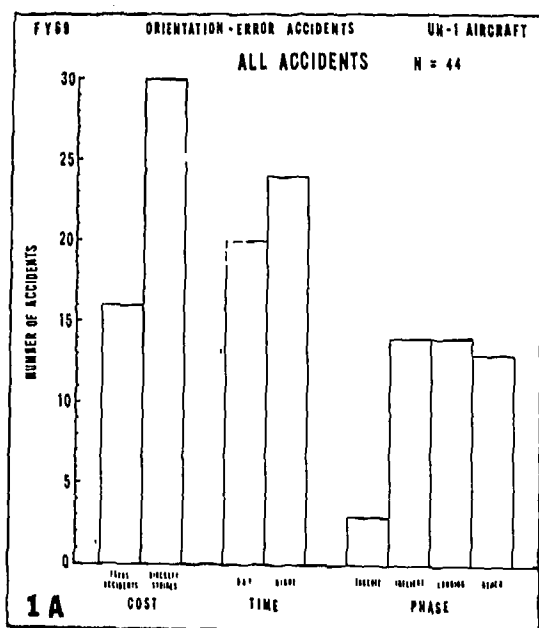
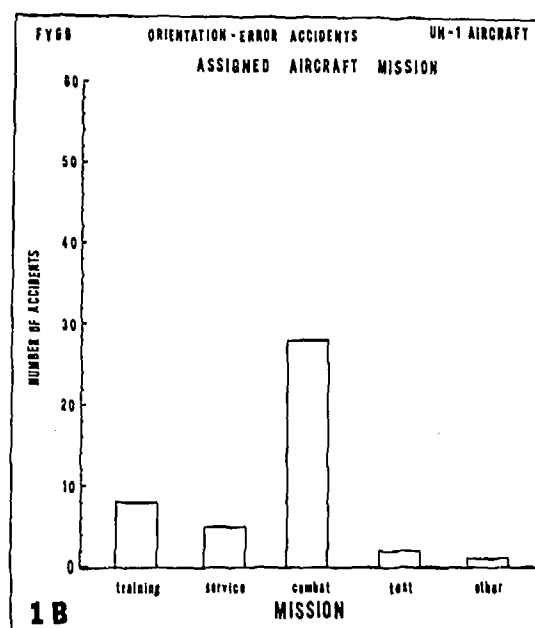
Figure 1

Major orientation-error accidents occurring in Regular Army UH-1 aircraft during fiscal year 1969. Number of fatal accidents, number of aircraft strikes, time of day of the accidents, and the flight phase in which the accident occurred (A); and types of missions assigned to the accident aircraft (B).

As indicated by the cost data presented in Figure 1A, the hazard of the orientation-error class of accidents was considerable for that fiscal year. Some 36.4 percent of the accidents were fatal, while 68.2 percent resulted in a total loss of the aircraft. The time-of-day data indicate that the incidence of accidents at night was slightly greater than the incidence during daylight. In terms of the phase of flight in which the accident occurred, 31.8 percent of the accidents occurred during the inflight phase, 31.8 percent during the landing phase, 29.5 percent during the "other" phase, and 6.8 percent during the takeoff phase. It should be noted that the "other" phase classification used in this report denotes localized operations, such as reparking an aircraft, lifting a sling load, or moving an aircraft to a nearby refueling site.

The mission data shown in Figure 1B indicate that the majority (63.6 percent) of the accidents occurred on flights that had some form of combat-related mission assignment. This would be expected since 37 (84.1 percent) of the accidents occurred in Vietnam. The reader is reminded that, although a combat mission may have been assigned to the crew, the resulting mishap was an accident and not a loss attributable to direct enemy action.

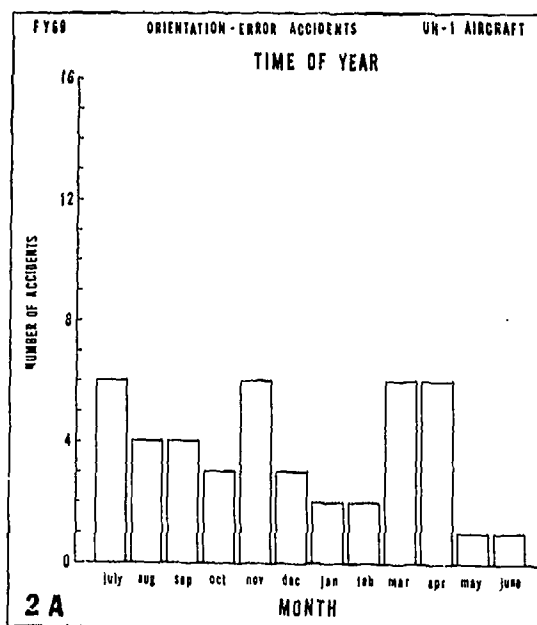
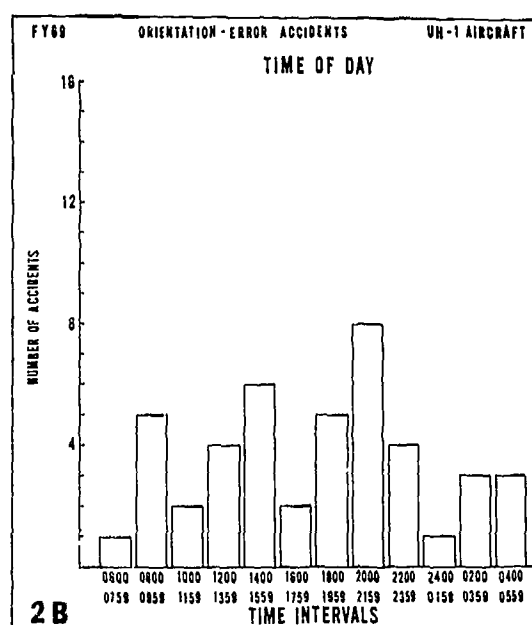
Figure 2

Number of orientation-error accidents as a function of the time of year (A) and the local time of day (B).

In Figure 2A a distribution is given of the number of accidents during each month of the fiscal year. Since the majority of the accidents occurred in Vietnam, the time-of-year incidence of accidents due to weather and dust peaked in that country's monsoon and dust seasons, respectively. Interpretation of these data beyond this point is restricted by the month-to-month variations in the level of combat operations being conducted at a given time. Similarly, the daily variation in frequency of operations would affect interpretation of the hourly distribution data plotted in Figure 2B, which shows accident incidence in 2-hour increments over a 24-hour period.

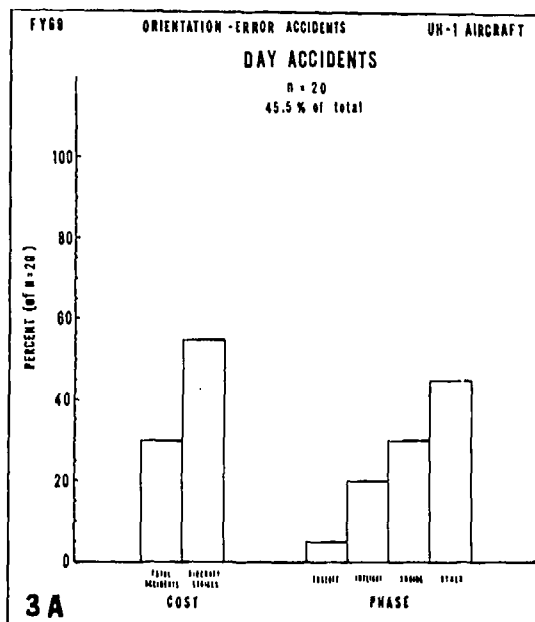
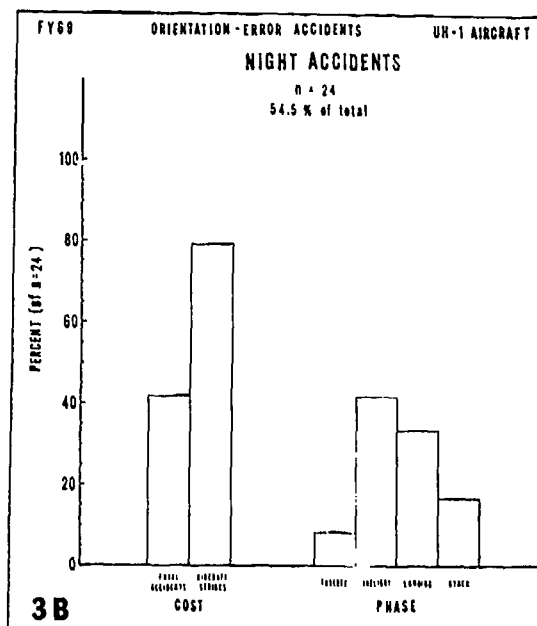
Figure 3

Comparison of percent incidence of fatal accidents, aircraft strikes, and flight phase for the 20 orientation-error accidents that occurred under daylight visibility conditions (A) and the 24 accidents that occurred under night visibility conditions (B). Note the considerably greater hazard of the night flights.

Additional data related to the time-of-day incidence of the orientation-error accidents are presented in Figure 3. Statistics pertaining to the 20 accidents that occurred under daylight visibility conditions are plotted in Figure 3A. Similar data for the 24

night accidents are shown in Figure 3B. It is obvious that the cost of night accidents in terms of fatal accidents and aircraft strikes was considerably greater than the corresponding costs for daylight accidents. That is, 41.7 percent of the night accidents were fatal as compared to only 30.0 percent of the daylight accidents; 79.2 percent of the night accidents resulted in aircraft strikes as compared to only 55.0 percent of the daylight accidents. In terms of the phase of flight for the night accidents, the greatest incidence occurred during the inflight phase (41.7 percent) followed by the landing, "other" and takeoff phases. For daylight accidents, incidence was greatest during the "other" phase (45.0 percent) followed by the landing, inflight, and takeoff phases.

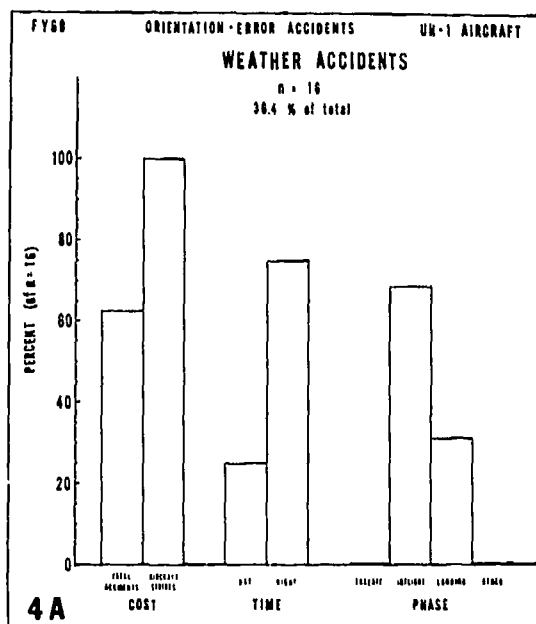
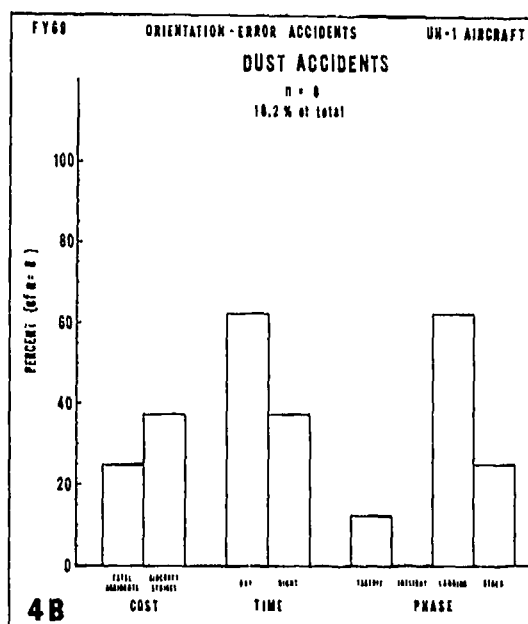
Figure 4

Comparison of percent incidence of fatal accidents, aircraft strikes, day/night accidents, and phases of flight for the 16 orientation-error accidents that involved poor weather (A), and the 8 accidents that involved rotor-raised ground dust or ashes (B). Note the high incidence of fatal accidents and aircraft strikes involved in the weather accidents.

Data pertaining to accidents involving degraded visibility due to weather and rotor-raised ground dust are presented in Figure 4. As denoted in Figure 4A, poor weather of one form or another was present in 16 (36.4 percent) of the 44 orientation-error accidents. The hazard of these weather accidents was most significant since 62.5 percent of the accidents were fatal and all resulted in aircraft strikes. A further significant feature was that the majority (75.0 percent) of the accidents occurred at night. Of the 12 accidents that occurred under these special conditions, i.e., visibility degraded both by weather and by darkness, 7 (58.3 percent) were fatal. Of the four weather accidents that occurred during daylight, three were fatal. With respect to the total of 10 fatal weather accidents, 7 (70.0 percent) of these occurred at night. In terms of the phase of flight when the accident occurred, the inflight phase had the greatest incidence (68.7 percent).

As indicated in Figure 4B, an additional 8 (18.2 percent) of the 44 orientation-error accidents involved degraded visibility due to rotor-raised ground dust. There were only 2 fatal accidents and 3 aircraft strikes in this classification. In contradistinction to the weather accident data, the majority (62.5 percent) of the dust accidents occurred under daylight visibility conditions. Relative to the phase of flight, landing accidents had the greatest incidence (62.5 percent) followed by the "other" and takeoff phases.

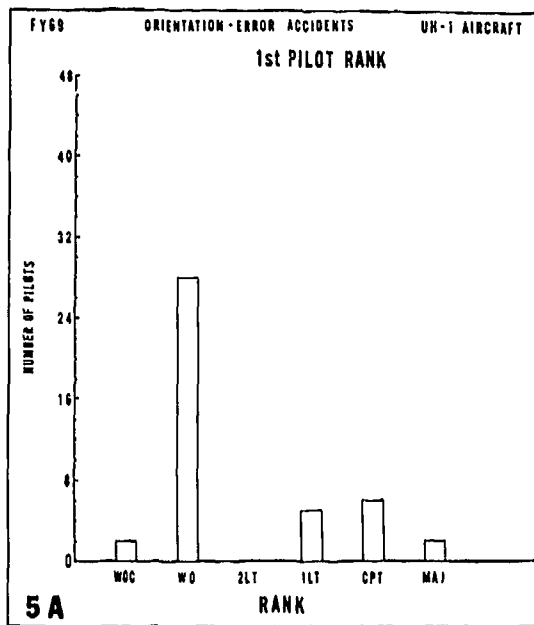
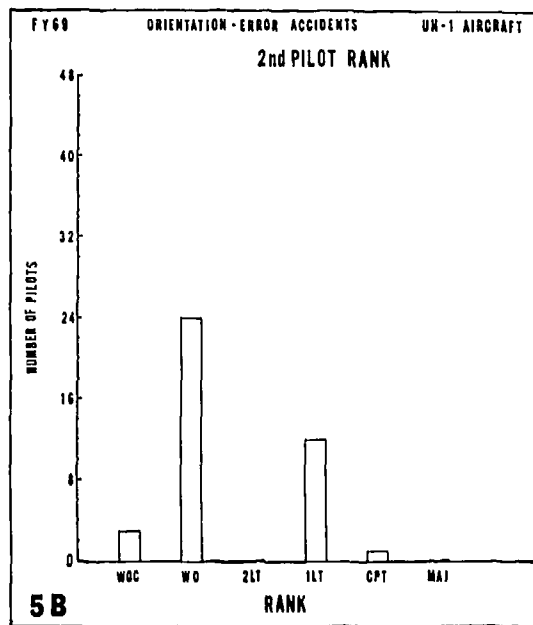
Figure 5

Distribution by rank of 43 first pilots (A) and 40 second pilots (B) involved in the orientation-error accidents. As explained in the text, the first pilot notation is used to describe the commanding aviator aboard the aircraft. In general, for Vietnam accidents, the first pilot is the "air commander" and the second pilot is the "pilot." For accidents occurring elsewhere, the first and second pilot notation usually corresponds to the conventional "pilot" and "copilot" designations, respectively.

Data pertaining to the military rank of the first and second pilots are shown in Figures 5A and 5B, respectively. Of the 43 first pilots for whom rank data were available, 13 (30.2 percent) individuals had a rank of second lieutenant or above. Similarly,

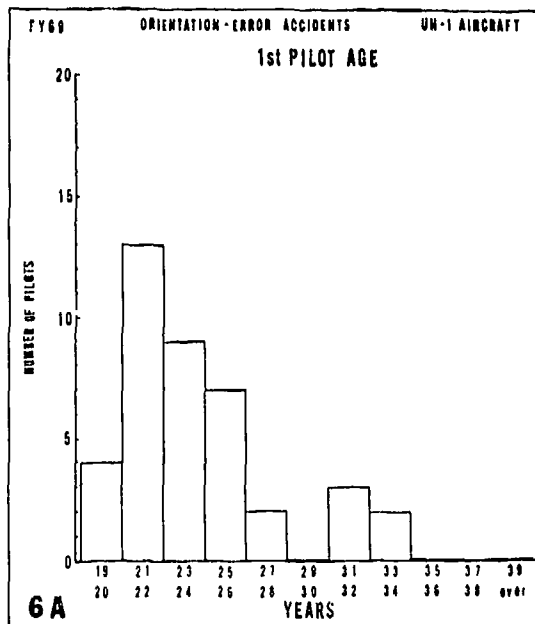
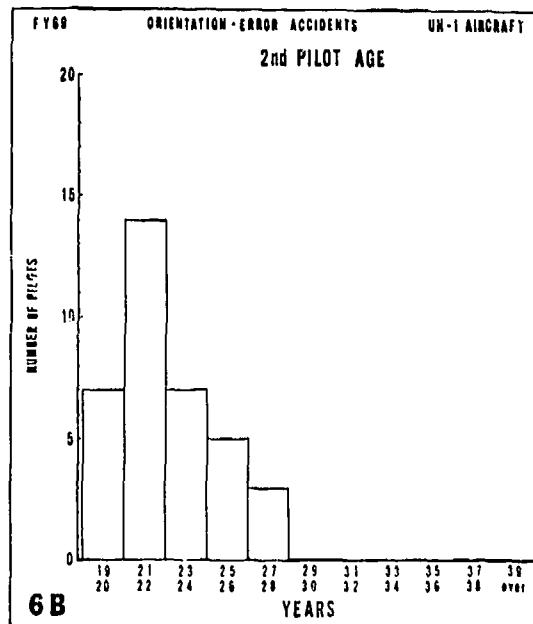
Figure 6

Age distribution of the first pilots (A) and second pilots (B). The median ages were approximately 23.7 years and 22.6 years, respectively.

for 40 second pilots, 13 (32.5 percent) individuals had a rank of second lieutenant or above. The age distribution data presented in Figure 6A for 40 first pilots indicates a median of 23.7 years; the Figure 6B data indicate a median of 22.6 years for 36 second pilots.

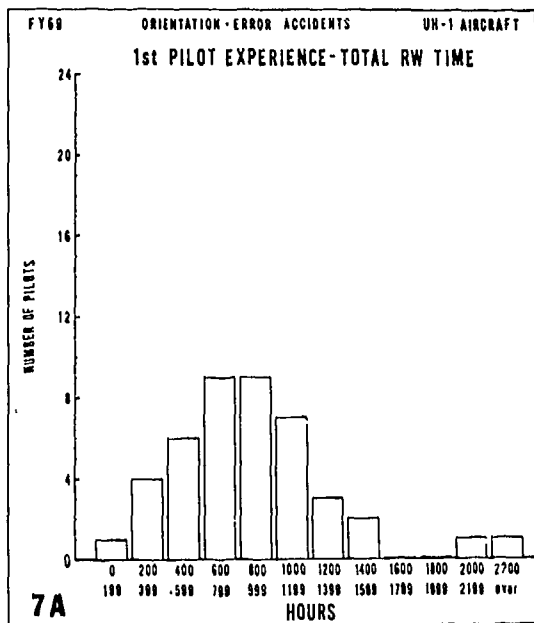
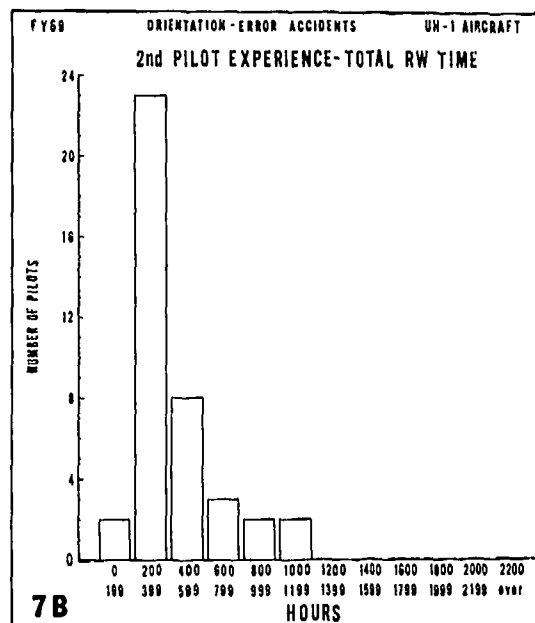
Distribution of total flight hours experience in military rotary-wing aircraft of the first pilots (A) and second pilots (B). The medians were approximately 833 hours and 356 hours, respectively. These data do not include any additional fixed-wing experience. (See Figure 10 for related FW and RW experience data.)

Aviator experience in terms of total flight hours both in all types of military rotary-wing (RW) aircraft and in the UH-1 aircraft is described by Figures 7 and 8, respectively. The median for the total recorded RW experience data presented in Figure 7 was 833 hours for 43 first pilots and approximately 356 hours for 40 second pilots. The median times for total UH-1 experience were approximately 417 hours and 125 hours for 42 first and 35 second pilots, respectively.

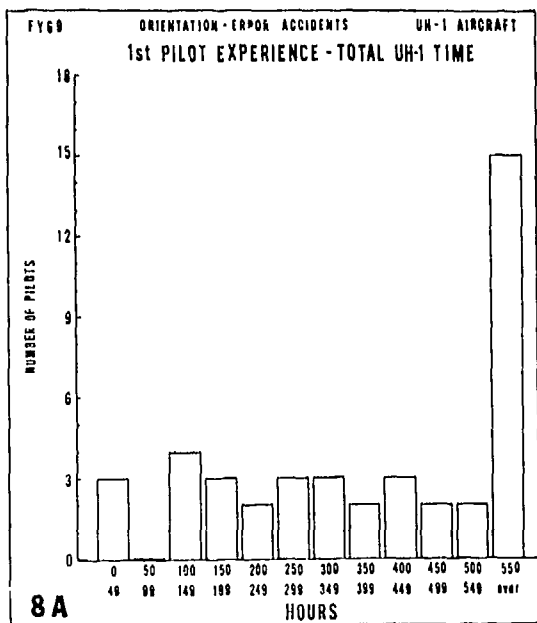
Figure 8

Distribution of total flight hours in the UH-1 aircraft of the first pilots (A) and second pilots (B). The median times were approximately 417 hours and 125 hours, respectively. (See Figure 10 for related UH-1 experience data.)

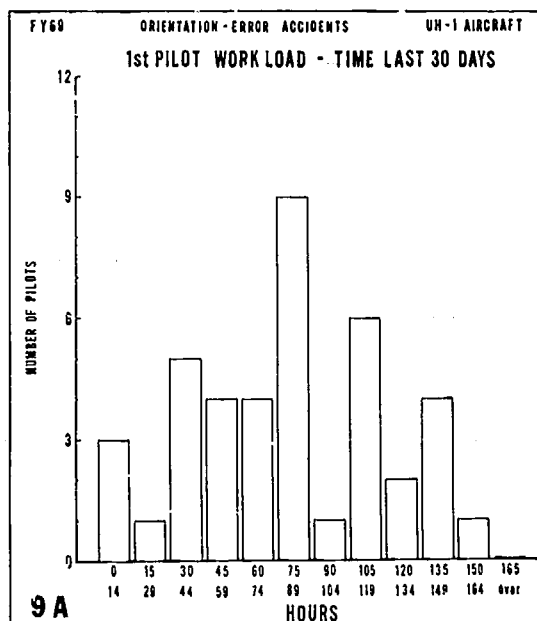
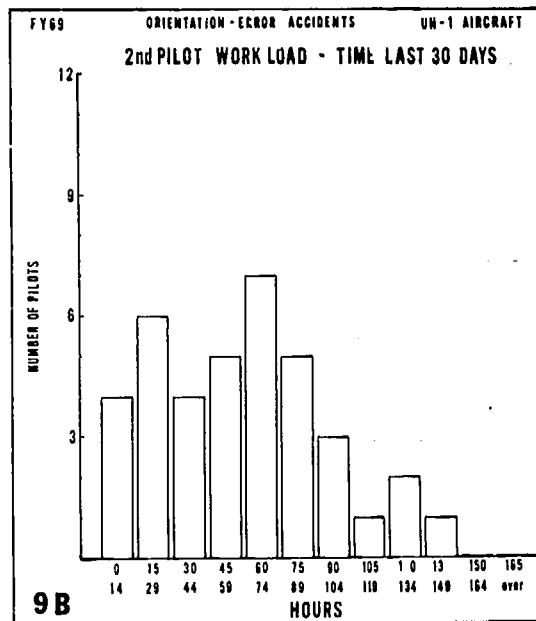
Figure 9

Distribution of pilot workload in terms of the total number of hours flown the 30 days preceding the accident by the first pilot (A) and the second pilot (B). The median workloads were 80 hours and 60 hours, respectively. (See Figure 10 for related fatigue listings.)

Work-load data concerned with the total number of hours flown by the aviators during the 30 days preceding the accident are shown in Figure 9; specific hours data were available for 40 first pilots and 38 second pilots. The median times were approximately 80 hours for the first pilots and 60 hours for the second pilots. Army regulations place 140 hours per 30-day interval as the official upper limit relative to pilot fatigue. After 90 hours, however, observation of the pilot by the air unit commander and flight surgeon is required.

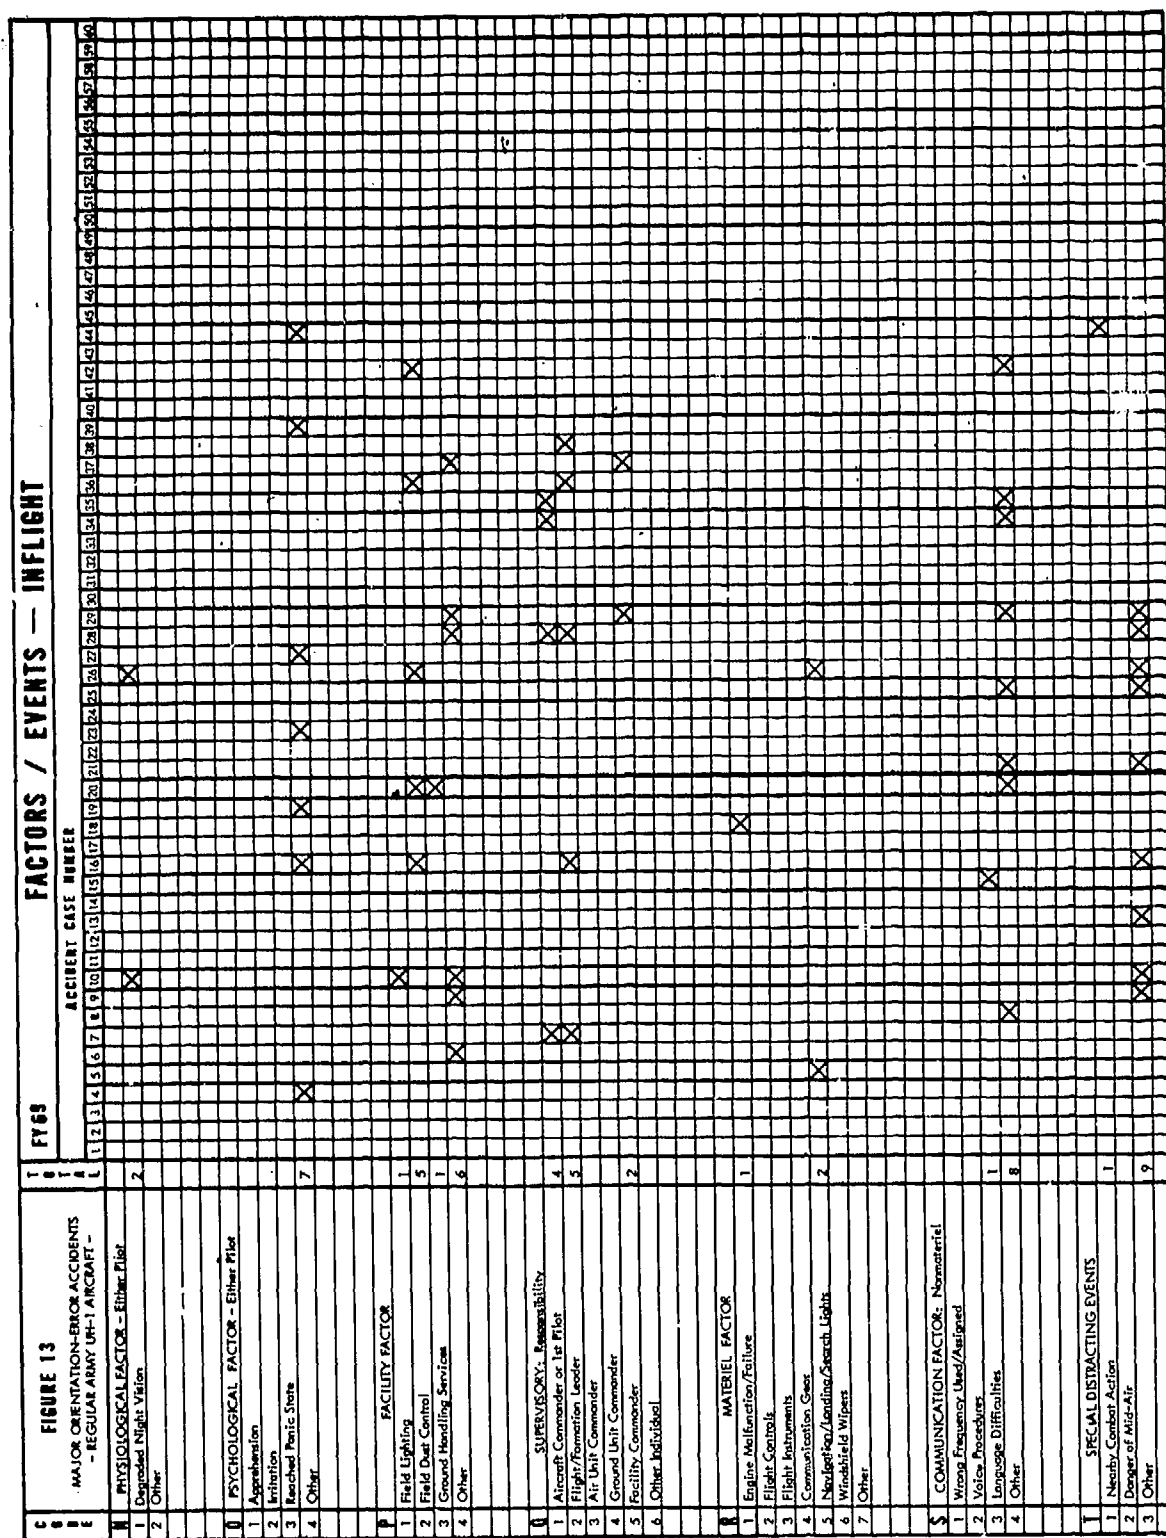
Figure 13

Individual case history listing of selected accident factors and events considered to have occurred, or to be first manifested to the crew, while the aircraft was inflight.

Factors similar to those in Figures 11 and 12 are outlined in Figures 13 and 14 but apply to the inflight phase of the 44 accidents. The N physiological factors and O psychological factor headings pertain to either pilot in this section since the accident review indicated that, in general, the inflight occurrence of such factors affected both pilots. The only physiological incident detected to occur inflight, other than the basic orientation-error event, involved night flights where some form of degraded night vision was highly probable. As indicated by the N1 entry, only 2 of the accidents involved this factor. The main criterion used in classifying this as a factor was that the crew had to be exposed to some form of high intensity illumination that was turned off shortly before the accident.

Section O is a listing of psychological factors that were coded as occurring inflight. This factor was coded as present in 7 (15.9 percent) of the accidents. A point of consideration relative to the total number of listings contained under the inflight psychological factors heading is that all the nonnormal incidents and events that occur inflight, whether they involve some materiel problem, some communication difficulty, or some change in visibility, can certainly affect the mental outlook of the crew. In this respect, the majority of the factors listed under all the other headings will have some psychological input.
